# GLOBAL

INSPECTIONS-NDT

**Haul Truck Sample  
Non Destructive Evaluation  
Truck Frame  
April 2011**

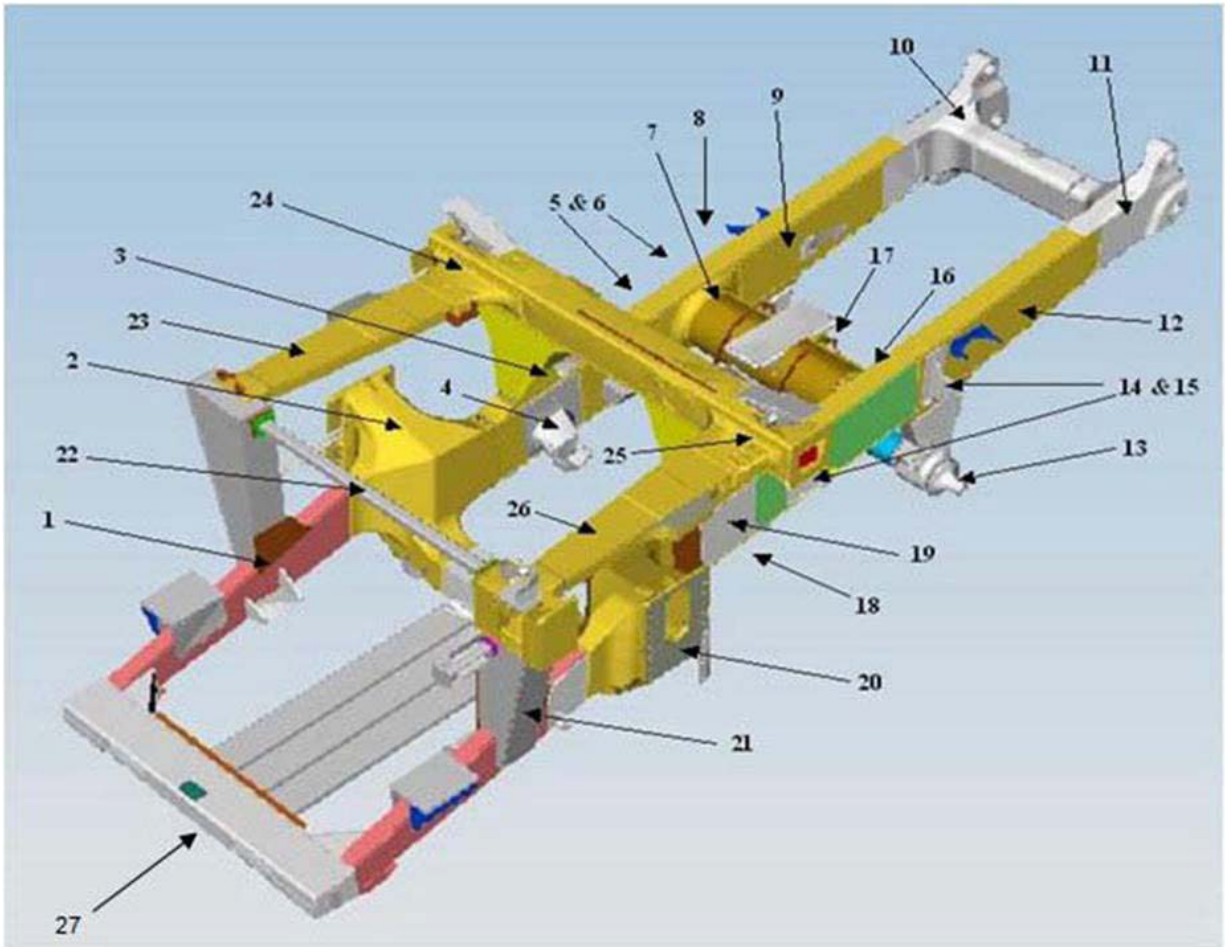
<u>Area #</u>	<u>Defects</u>
(# 2) Left and Right	Defect found on the left side
(# 3) Left and Right	Defect found on the right side
(# 17) and (# 16)	Defect found on # 7
(# 24) and (# 25)	No Defects Detected

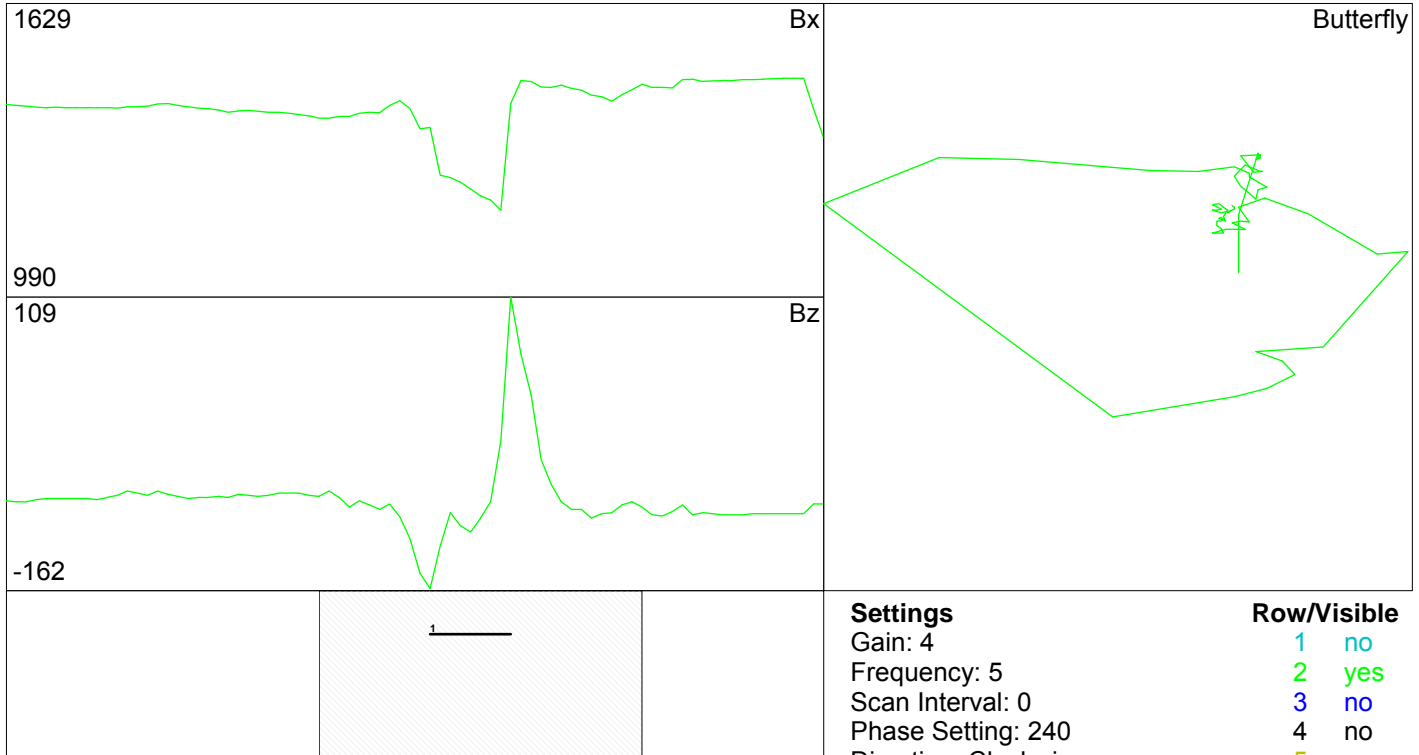
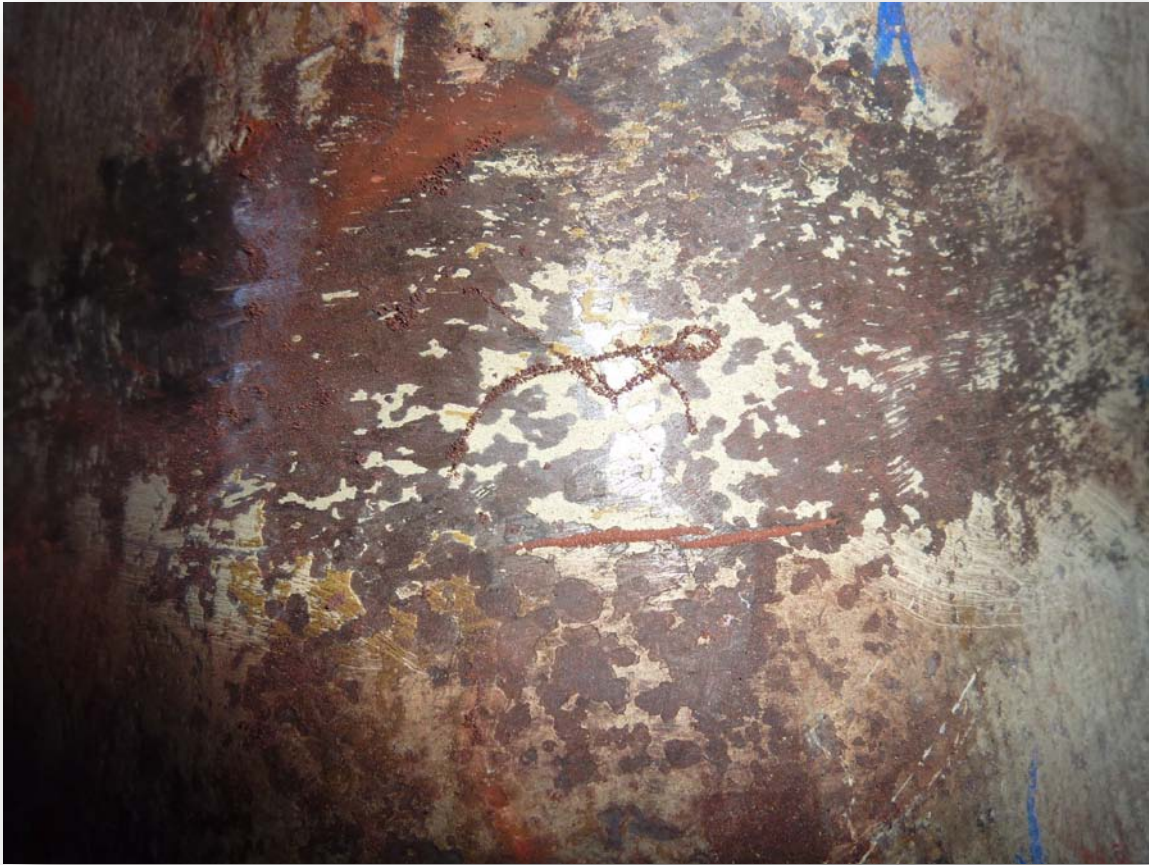
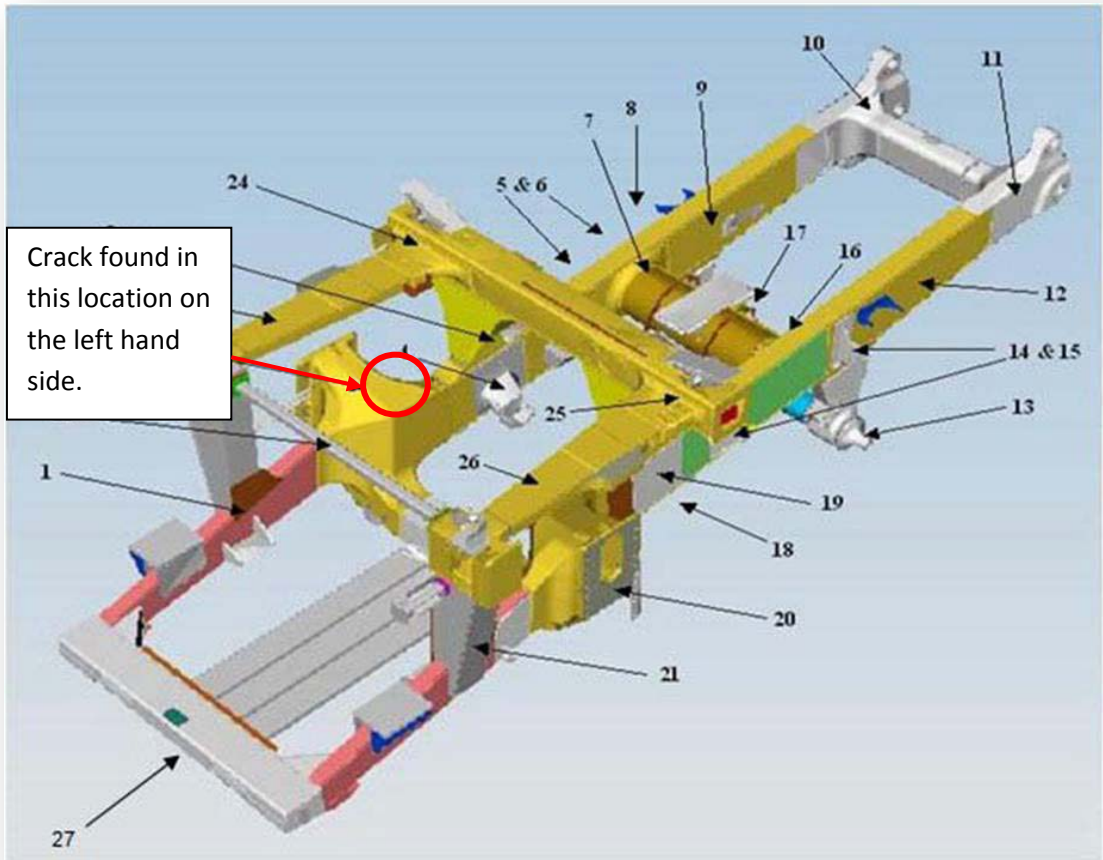
**Component:** right front strut  
**Test Date:** 4/12/2011  
creek

Len	Depth	Row(s)	Centre	Coat	CF
1: 38 mm	10.2 mm	2		0.0 mm	0.90

Crack found on the front left strut on the top of the part.

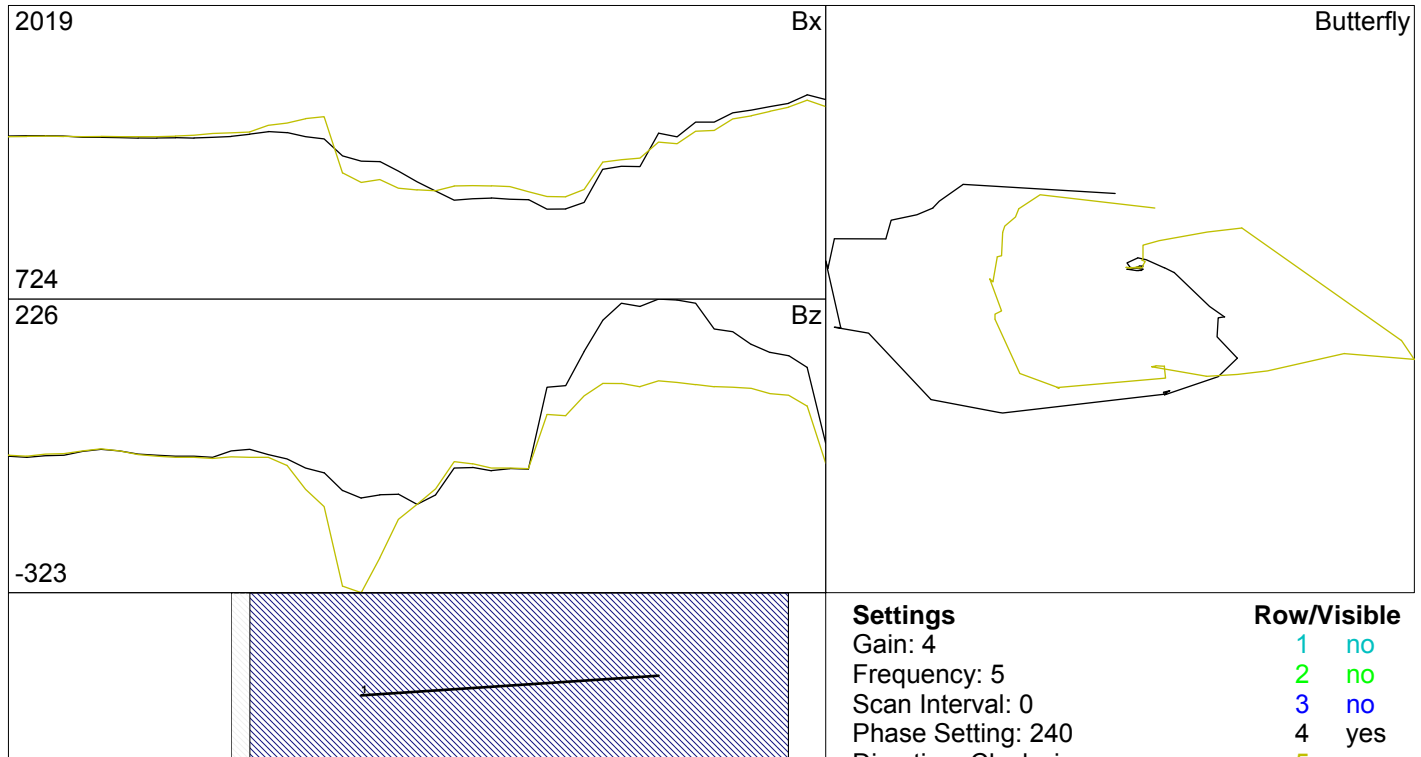
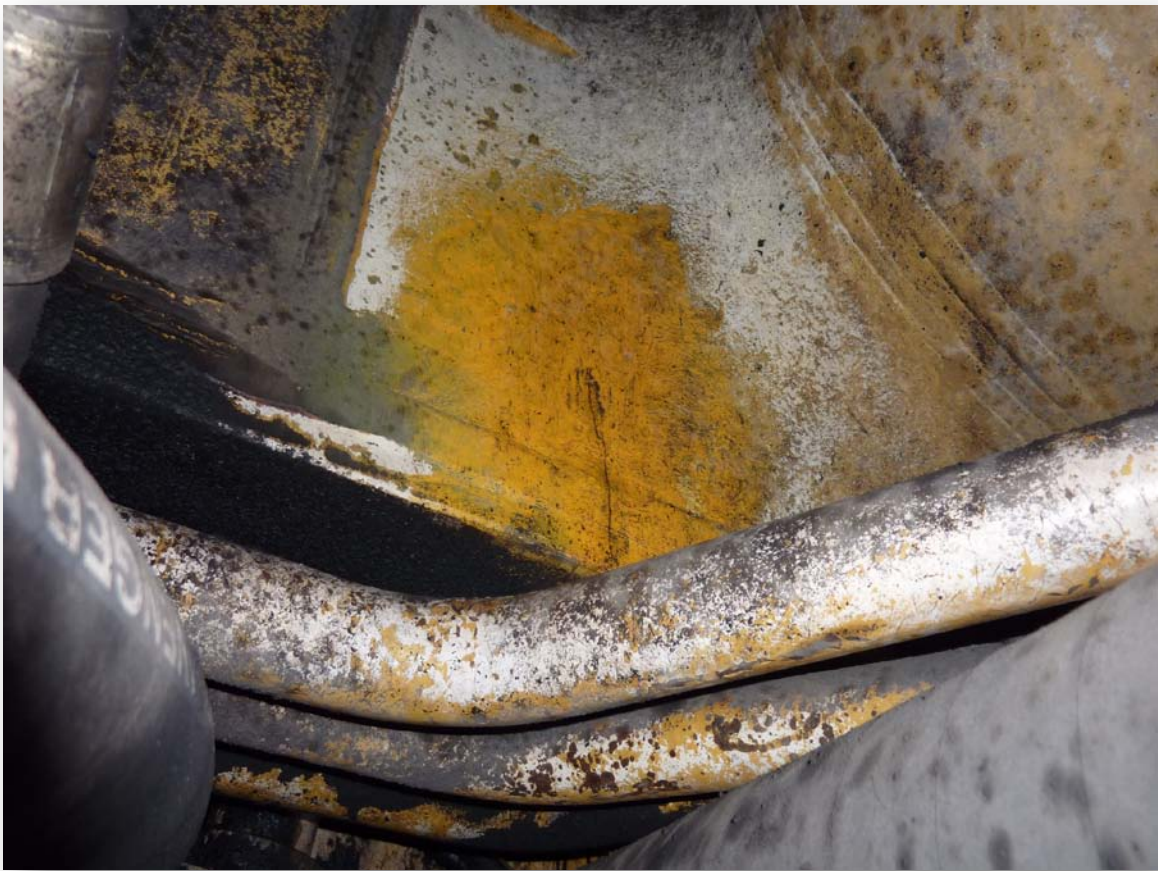
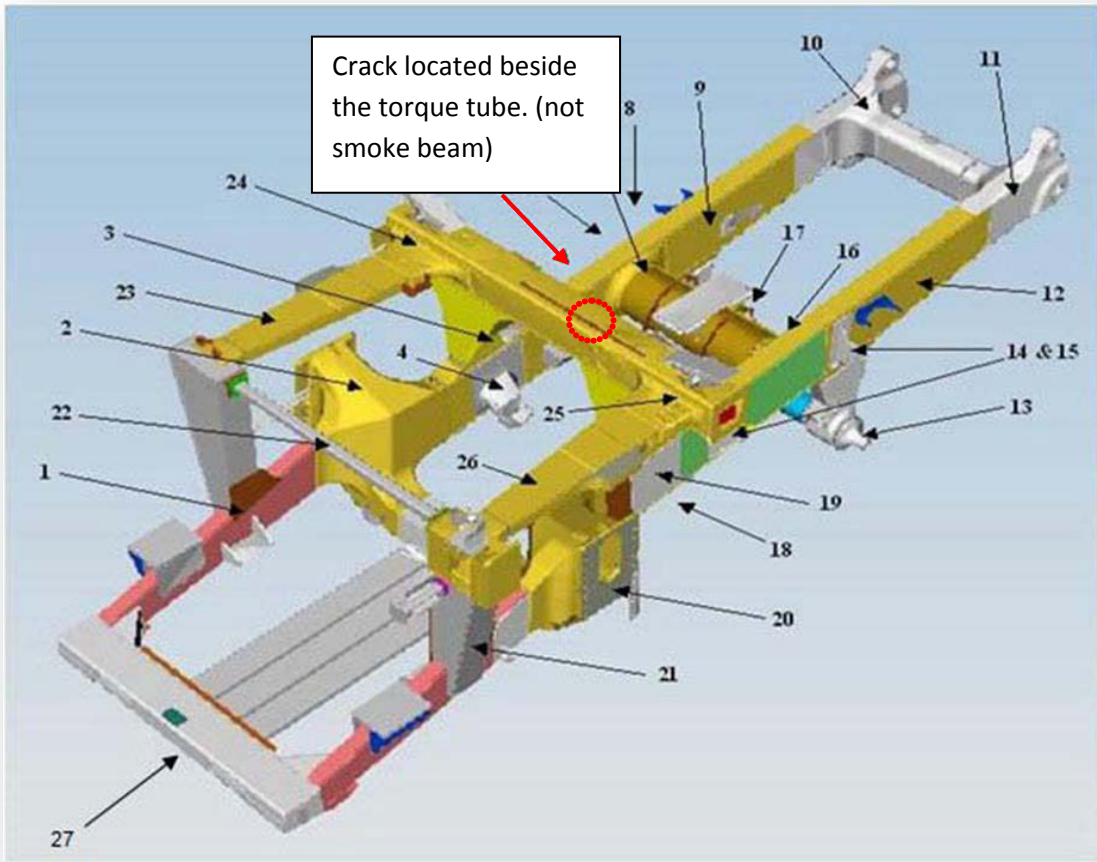
**Component:** right torque tube  
**Test Date:** 4/12/2011  
creek

Len	Depth	Row(s)	Centre	Coat	CF
1: 95 mm	> 47.4 mm	5 to 4		0.0 mm	0.90

Crack found near the right torque tube area on the plate welded to the box frame.

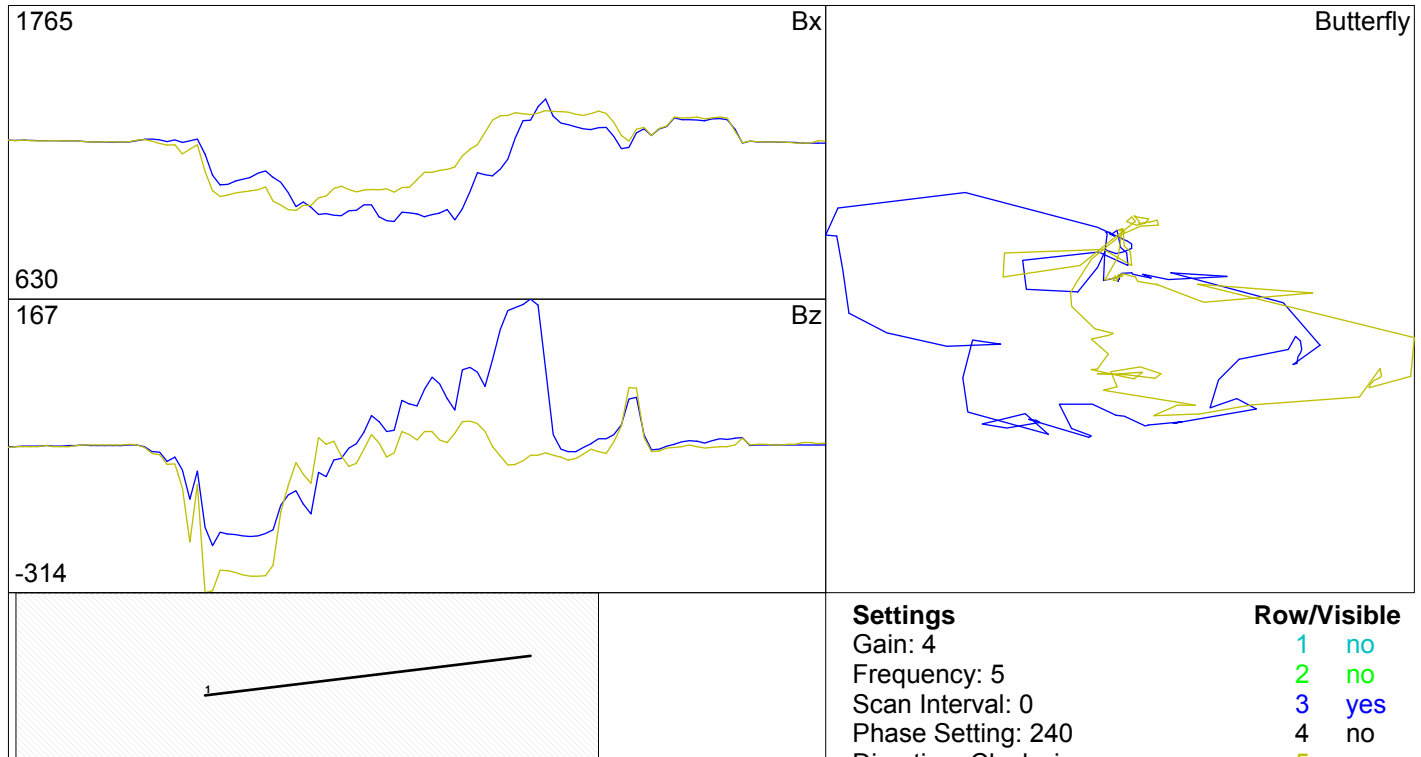
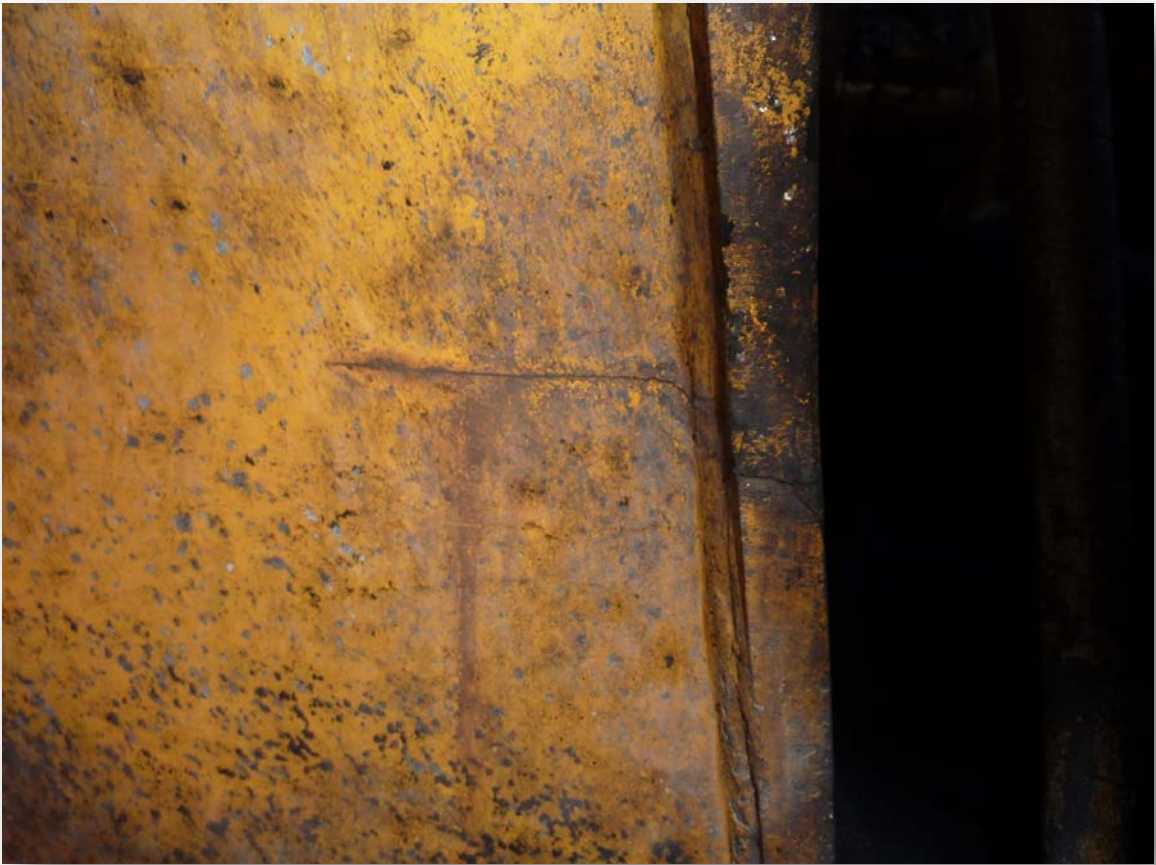
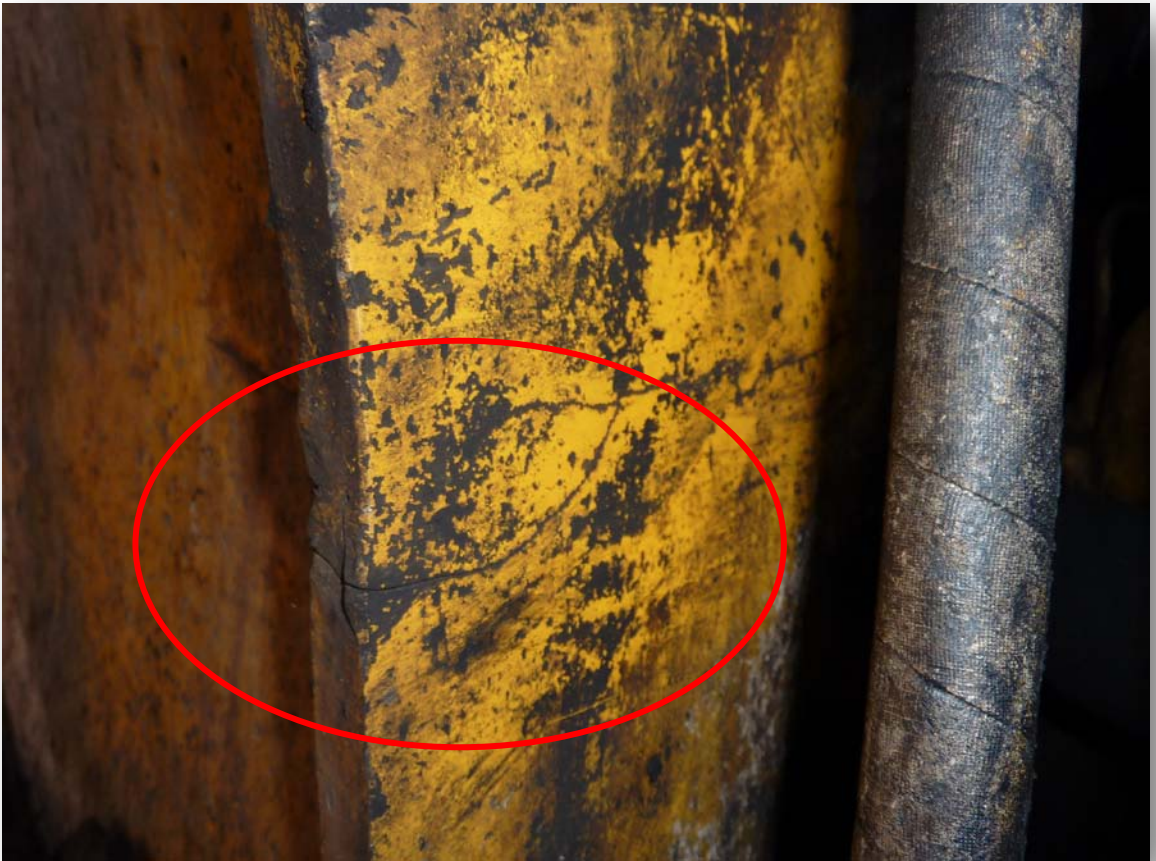
**Component:** right front strut  
**Test Date:** 4/12/2011  
creek

Len	Depth	Row(s)	Centre	Coat	CF
1: 157 mm	> 78.5 mm	5 to 3		0.0 mm	0.90

Crack found on the front right strut located near the top.
